## 5. *Assessment of Existing Conditions*

The assessment of the existing condition of the sites and facilities at MCC is an important step in understanding the challenges and opportunities for future change. This baseline knowledge, when combined with instructional programming goals, enrollment goals, and space utilization goals provides a solid foundation for creating an effective and meaningful master plan.

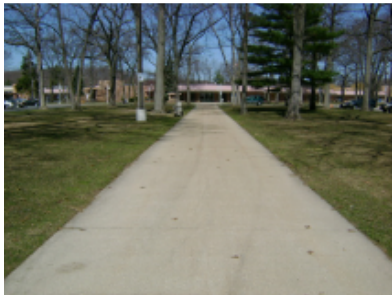
Structurally, the building scored lower due to the poor condition of the existing roof. The College is currently engaged in a program that will result in the replacement of the roof of the entire Academic Building and Frauenthal Fine Arts Center, so the recommendation for a new roof is not included in this master plan.

The building envelope scored low because of the poor insulative quality of the existing roof, walls and glass areas, in addition to the condition of the existing exterior doors and frames. Many of these elements are original or in excess of twenty years old.

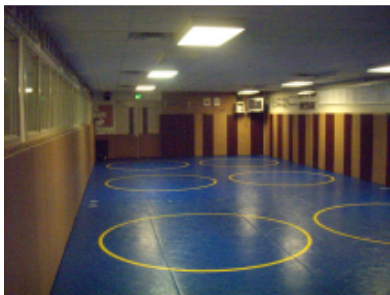
Because the entrance faces east, the building's exterior does not have an easily-identified entry and is beginning to reflect its age in terms of its condition and overall curb appeal.

Structurally, the condition of the roof is poor and is planned for replacement as part of the program involving the Main Academic Building. Also, the condition of some interior and exterior walls caused the facility to be in the "borderline" category.

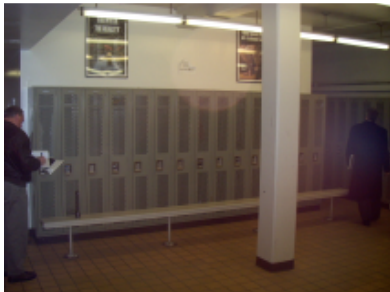
The Building envelope scored in the "poor" category due to similar reasons to the Main Academic Building: poor roof insulation, poor wall insulation, poor quality of exterior windows, and the condition of exterior doors and frames. In addition, there is little natural light that penetrates this building.

While the building has been maintained well, many of the interior finishes are original, or have been only modestly addressed over the years. All finishes and the condition of equipment, etc. put the building's interior in the "borderline" category, although new bleachers are planned for the gym.

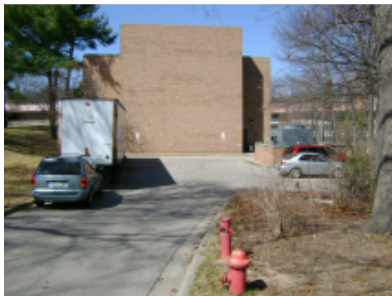
From a site perspective, the Frauenthal site is satisfactory in its existing condition, though it lacks parking for theater staff and delivery vehicles. The sculpture court adjacent to the entrance appears neglected and little used.

The building exterior is “borderline”, with a need for more prominent signage, an enhanced entrance, and overall curb appeal. Similarly, the facility is “borderline” in terms of accessibility.
