March 3, 2010

RE: Muskegon Community College  
Master Plan Review - Floor Structure Cracks  
JDH File 0912-015

October 21, 2009

**Re: Structural Investigation of Several Campus Buildings – Updated per Req. #6663**

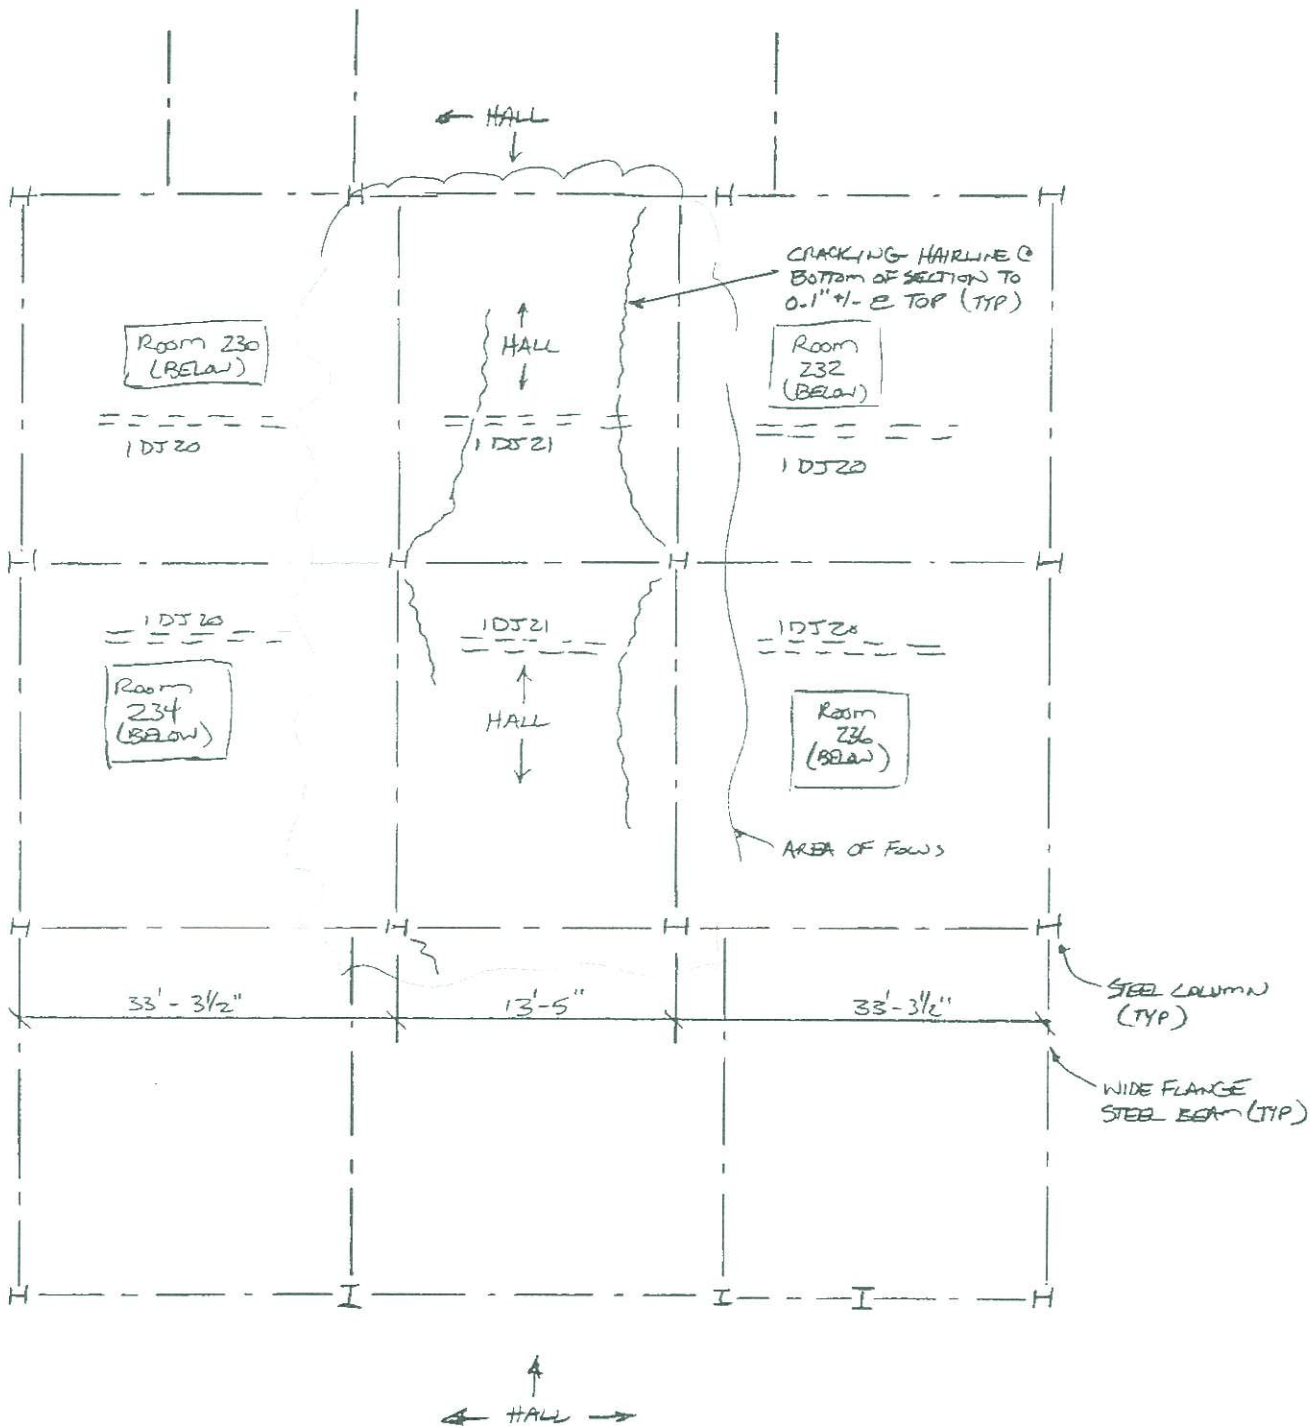
SCHEMATIC OF "FIRST FLOOR FRAMING PLAN"  
(BETWEEN 2<sup>ND</sup> & 3<sup>RD</sup> FLOORS OF BUILDING)

The second factor considered is the design on the construction plans and possible misinterpretations by contractors. Sheet S13 shows the framing for the area in question. It indicates that the joists spanning the hallway area are to be a "1DJ21", which is a 5"x8" joist with integral 2-1/2" floor slab and a "1DJ20", which is a 6"x14" joist with integral 3" floor slab spanning the adjacent classrooms. For high stresses due to negative moment to be a primary cause of the cracking, the joists and flooring would have to be at least partially continuous at the support. Based on our review of the drawings it is possible that a contractor misunderstood whether the joists were to be constructed continuous over the support beam. First, the notes on sheet S5 indicate "concrete joists shall be spaced for continuous construction from bay to bay unless otherwise shown on the drawing". Under the "Remarks" column of the joist schedule on sheet S13, it indicates that the 1DJ21 joists are not to be continuous with the 1DJ20 joists. However, the construction joints at the support beam were specifically called out on the plans for Part C of the building, but the callout was omitted from the area in question in Part D. Also, the building is fairly symmetric in Part D, and the opposite area appears to be designed for continuous construction. Finally, the joist schedule calls for a #3 dowel bar, 3' long, to be placed across the construction joint at each joist, which would at least partially fix the joint and allow negative moment transmission. Based on these items, it is possible that the contractor misinterpreted the design intent and constructed 1DJ20 and 1DJ21 continuous and did not leave a break in the welded wire fabric reinforcement in the slab. Finally, the joist callouts appear to show the concrete joists parallel to the hallway as opposed to perpendicular, which appears to be the design intent and is how they were constructed. This could have caused further confusion during construction and possibly resulted in improper orientation of the welded wire fabric, which would further reduce the section's ability to resist negative moments.

Based on these two factors, we feel that enough negative moment was transmitted through the joints at the supports of the 1DJ21 joists to cause cracking of the section. Since the reinforcement in the floor slab is nominal welded wire fabric for temperature and shrinkage, the cracking has opened and propagated under loading. We also noted the welded wire fabric exposed in one of the cracks because it was placed with limited cover near the bottom of the floor slab. This lower position would reduce the fabric's effectiveness in resisting moments and allow wider growth of cracking.

Due to the severity of the cracking, we recommend that MCC consider a repair/retrofit to the area to prevent further damage to the structure and increase reliability. A retrofit could take the form of supplemental carbon fiber reinforcement applied to the top of the flooring, a supplemental steel system from the bottom of the section in conjunction with sealing of the cracking or another approach designed to reinforce the section. During our site visit, we marked and recorded crack widths in a number of areas. Because the timeline to budget, plan, design and construct repairs could be a lengthy one, we recommend that the cracking be monitored for further progression. We also recommend reviewing the corresponding area in Part "C" of the building, because it is similar in design.
