## 5. *Assessment of Existing Conditions*

The assessment of the existing condition of the sites and facilities at MCC is an important step in understanding the challenges and opportunities for future change. This baseline knowledge, when combined with instructional programming goals, enrollment goals, and space utilization goals provides a solid foundation for creating an effective and meaningful master plan.

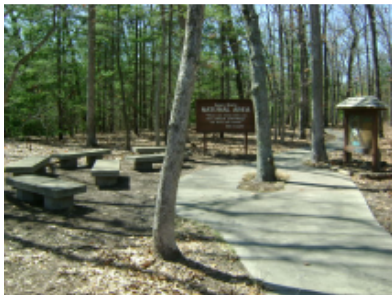
West of the Main Academic Building is the **Kasey Hartz Nature Trail**, including a trail-head gathering area and a winding natural trail through the woodlands and creek areas. The trail is not easily visible or noted with signage in high use areas of campus and therefore may go unseen by many visitors. Barrier-free access is limited.

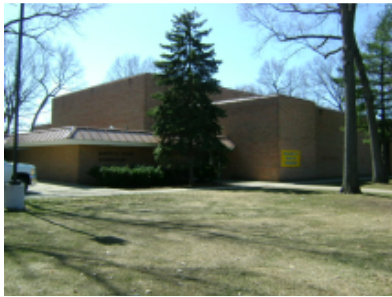
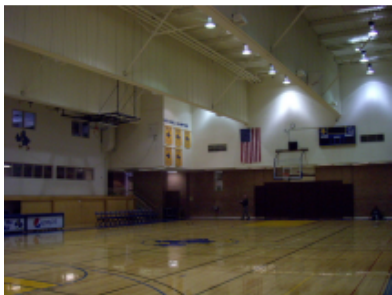
### **Bartels-Rode Gymnasium**

The site for this facility scored well on the assessment instrument. The condition of the outdoor fields is good, though there are signs of deterioration beginning to show in the condition of the dugouts. The archery range should be lengthened to meet instructional requirements, and the tennis courts all display significant cracking of the playing surfaces.

Structurally, the condition of the roof is poor and is planned for replacement as part of the program involving the Main Academic Building. Also, the condition of some interior and exterior walls caused the facility to be in the "borderline" category.

The Building envelope scored in the "poor" category due to similar reasons to the Main Academic Building: poor roof insulation, poor wall insulation, poor quality of exterior windows, and the condition of exterior doors and frames. In addition, there is little natural light that penetrates this building.

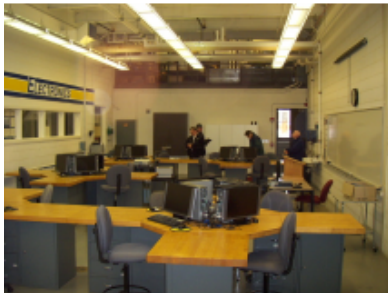
### Technology Building

The building has a “satisfactory” exterior rating. Brickwork at the parapet level of the boiler room is showing moisture penetration and spalling, however.

Accessibility to the building is satisfactory, as is the condition of the structure though the roof is planned to be replaced as part of the maintenance program. Similarly, the building envelope lacks insulation and upgraded exterior glass and exterior doors and frames.

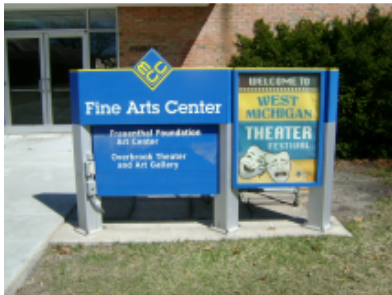
### *Frauenthal Foundation Fine Arts Center*

From a site perspective, the Frauenthal site is satisfactory in its existing condition, though it lacks parking for theater staff and delivery vehicles. The sculpture court adjacent to the entrance appears neglected and little used.

The structural condition is “borderline”, due primarily to the condition of the existing roof, which is scheduled for replacement.
